4.2 Risk Management of Gedung Sate as a Cultural Heritage

2. Studied Area for Disaster Risk Management Planning

This study selected Gedung Sate building as study area for disaster risk management planning. Located in the center part of Bandung, Gedung Sate is one of well-known historical heritage buildings in Bandung and it becomes landmark of the city. Its construction took from 1920 to 1924 designed by a Dutch architect, Ir. J. Gerber. He intended to set it as the main building of other 24 planned buildings for new site location of Dutch colonization office in Indonesia. However, there were only three of them -including Gedung Sate- completed successfully before the project stopped because of European economic crisis in 1930. Afterwards, it was used by Department of Public Works of Dutch East Indies until the independence of Indonesia in 1945. Then, Ministry of Public Works of Indonesia replaced its function as one of its branch offices in West Java area until 1980. Today, it is used for the office of Governor of West Java Province (Fig. 1).

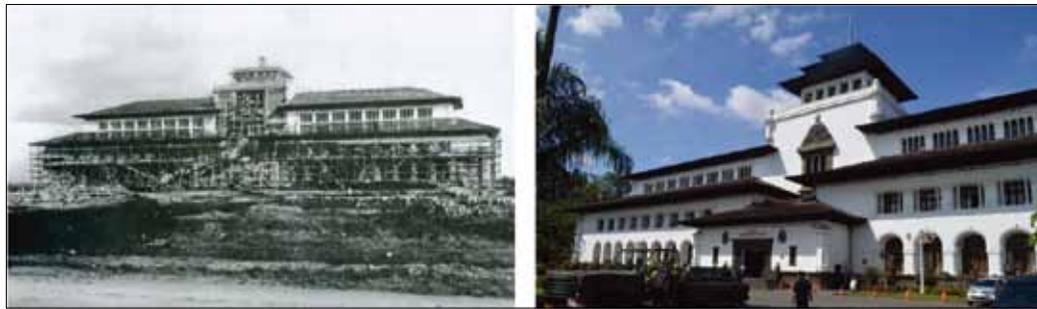
Fig. 2 Gedung Sate When Constructed (1924) and Gedung Sate Today (2014)

The building has been hit by several major earthquakes, such as Tasikmalaya Earthquake 2009 (7.3 Richter scale), Pangandaran Earthquake 2006 (6.8 Richter scale), and Yogyakarta Earthquake 2009 (5.9 Richter scale). Volcanic ash fall produced by volcanic eruptions in West Java region also struck the building and disrupted activities inside the building, such as Mount Tangkuban Parahu (1929), Mount Galunggung (1980), and Mount Merapi (2010). In recent years, the surrounding area of Gedung Sate is frequently flooded due to drainage problems. However, no substantial damage and losses to Gedung Sate due to those events was reported (Fig. 2).
